New York State Department of Transportation

Yellow Flag NB23U4W016

BIN: 1065318

Feature Carried: 278I278IX2M23027

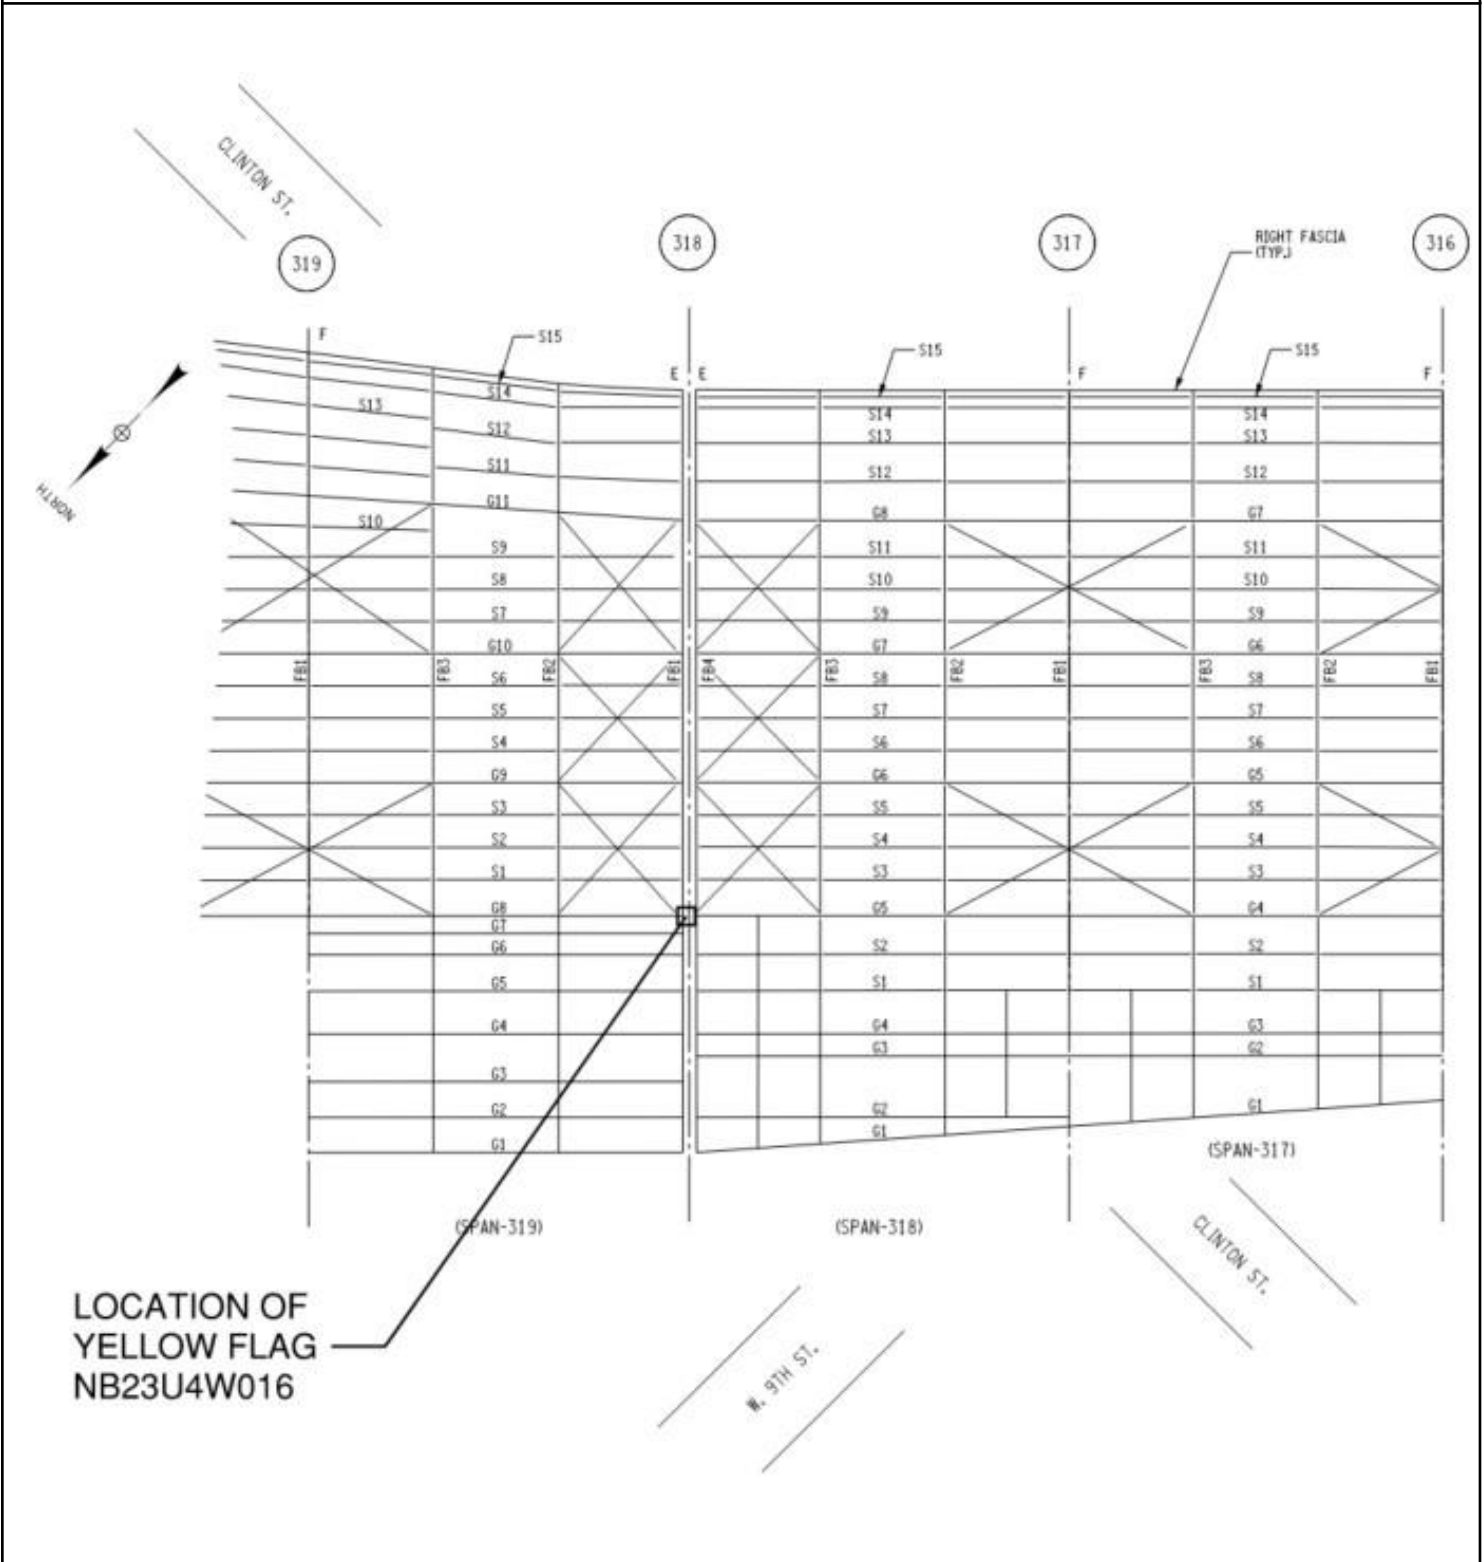
Photo Number: 1

Attachment Description: Flag Location Plan

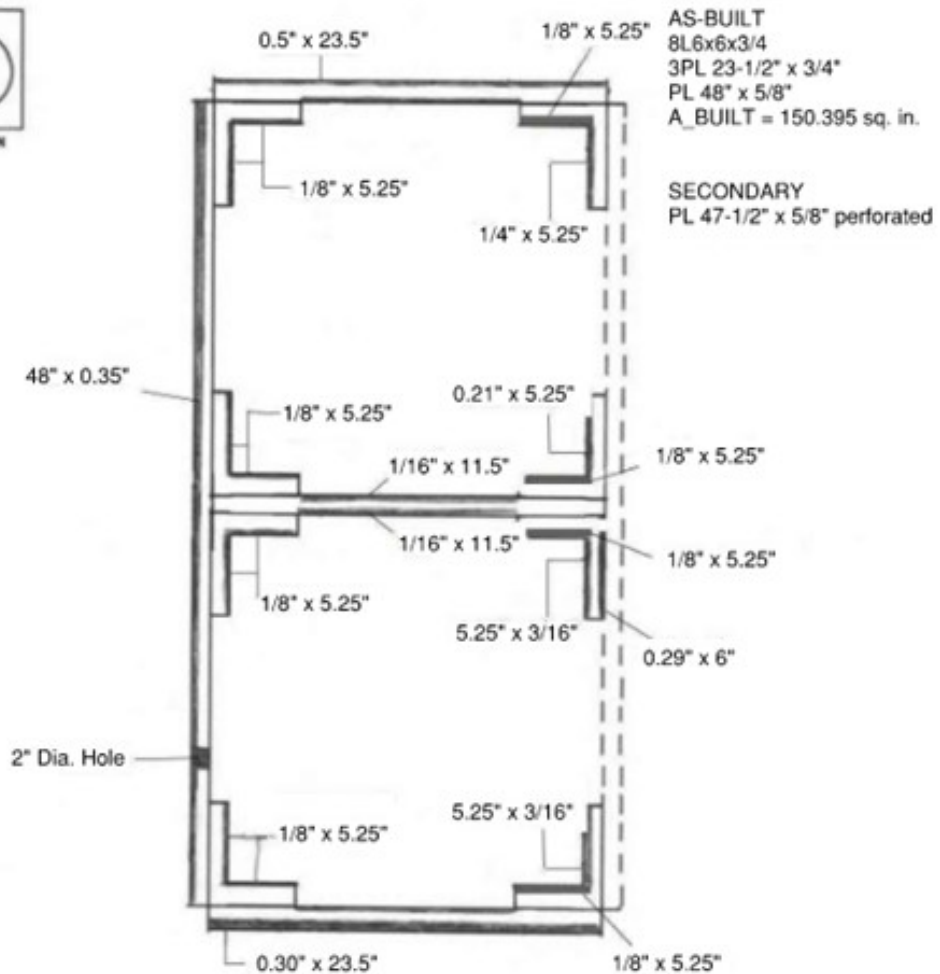
Photo Number: 2

**Section Loss - Column C3 (at base)**

Left Plate - 0.35" x 48" = 16.8 sq. in.

End Plate - 0.5" x 23.5" = 11.75 sq. in.

Begin Plate - 0.3" x 23.5" = 7.05 sq. in.

Inner Plate - 1/16" x 2 x 11.5" = 1.44 sq. in.

Connection Angles SL - (1/8" x 12 + 3/16" x 2) x
5.25" + 0.29" x 6" + 0.21" x 5.25" + 0.25" x 5.25"
= 14 sq. in.

Overall Section Loss - 51.04 sq. in.

Original As-built Area - 150.4 sq. in.

Overall Section Loss - 33.9%

PIER 318 C3
NTS

Total Section Loss = 51.04 sq. in.
% Section Loss = 34%

Secondary Plate at right face was not included in calculations.**Attachment Description: Flag Condition Sketch**

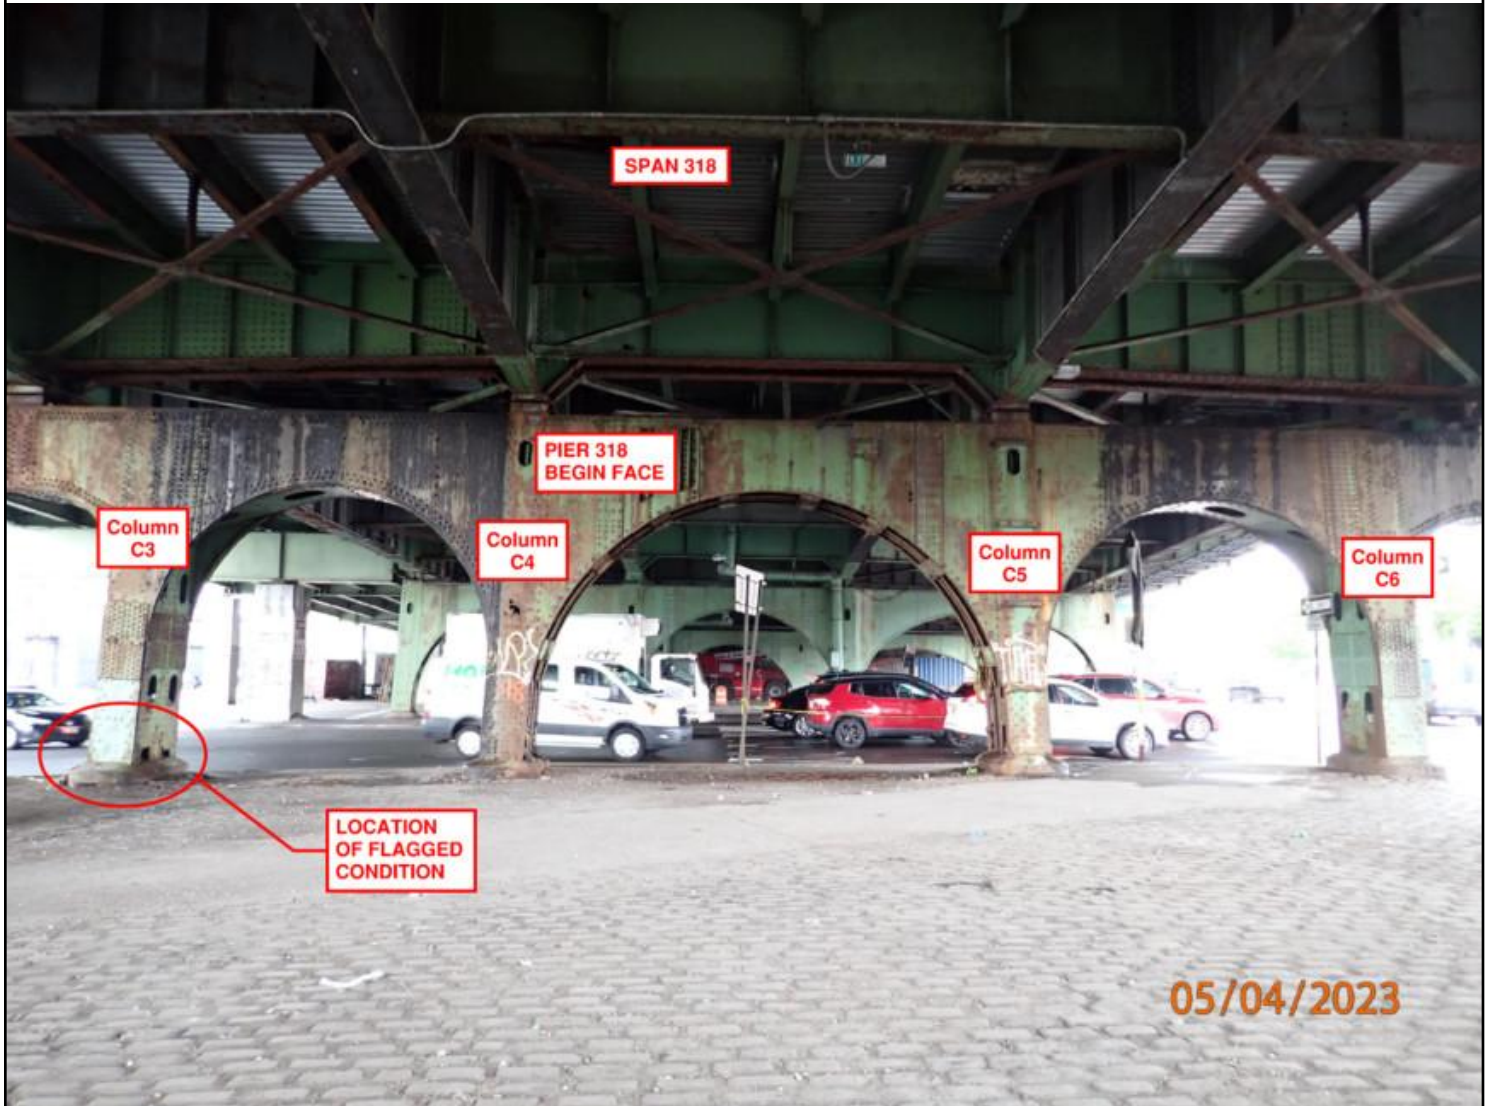
Photo Number: 3

Description: Column C3 exhibits 34% (previously noted as 35%) overall section loss at the base of the column interface with the concrete encasement, with a 2" diameter corrosion hole above the concrete encasement. There has been no significant changes since the previous inspection.

Attachment Description: Pier 318 Begin Face. General view of the flagged location in Column C3. Looking End.

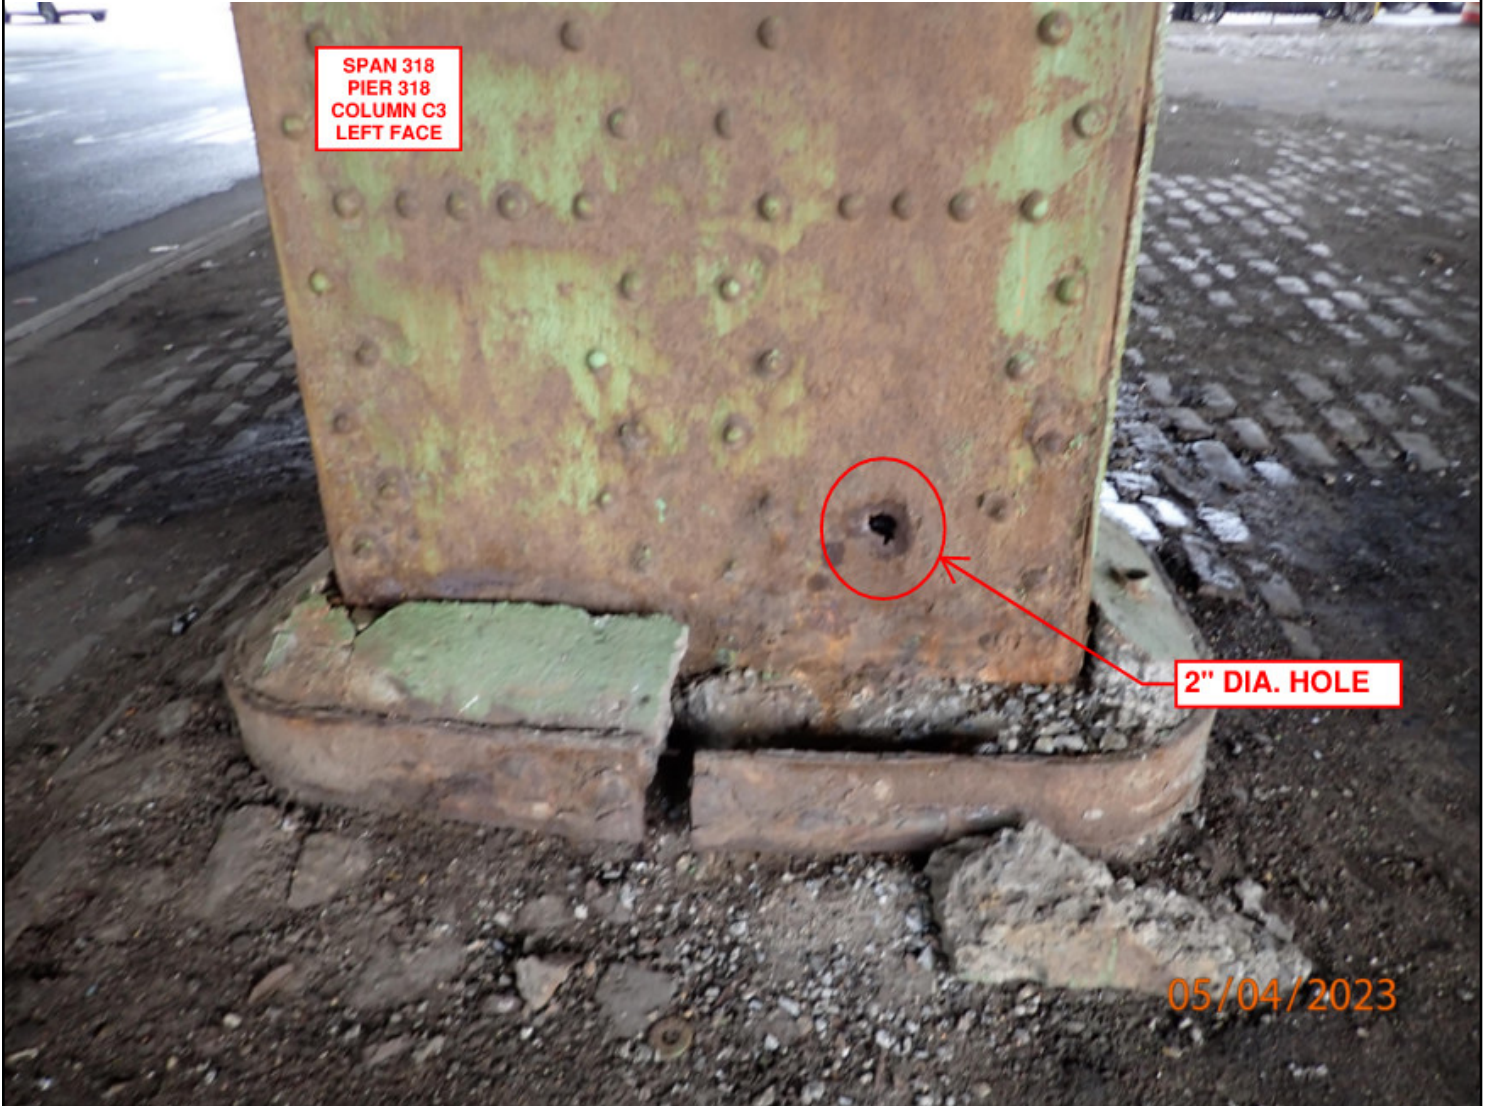
Photo Number: 4

Attachment Description: Span 318, Pier 318 Column C3 Left Face. Heavy pitting at the base of the column with a 2" diameter corrosion hole above the concrete encasement. Looking Right. Note: The broken concrete encasement issued a NSCO under separate cover.

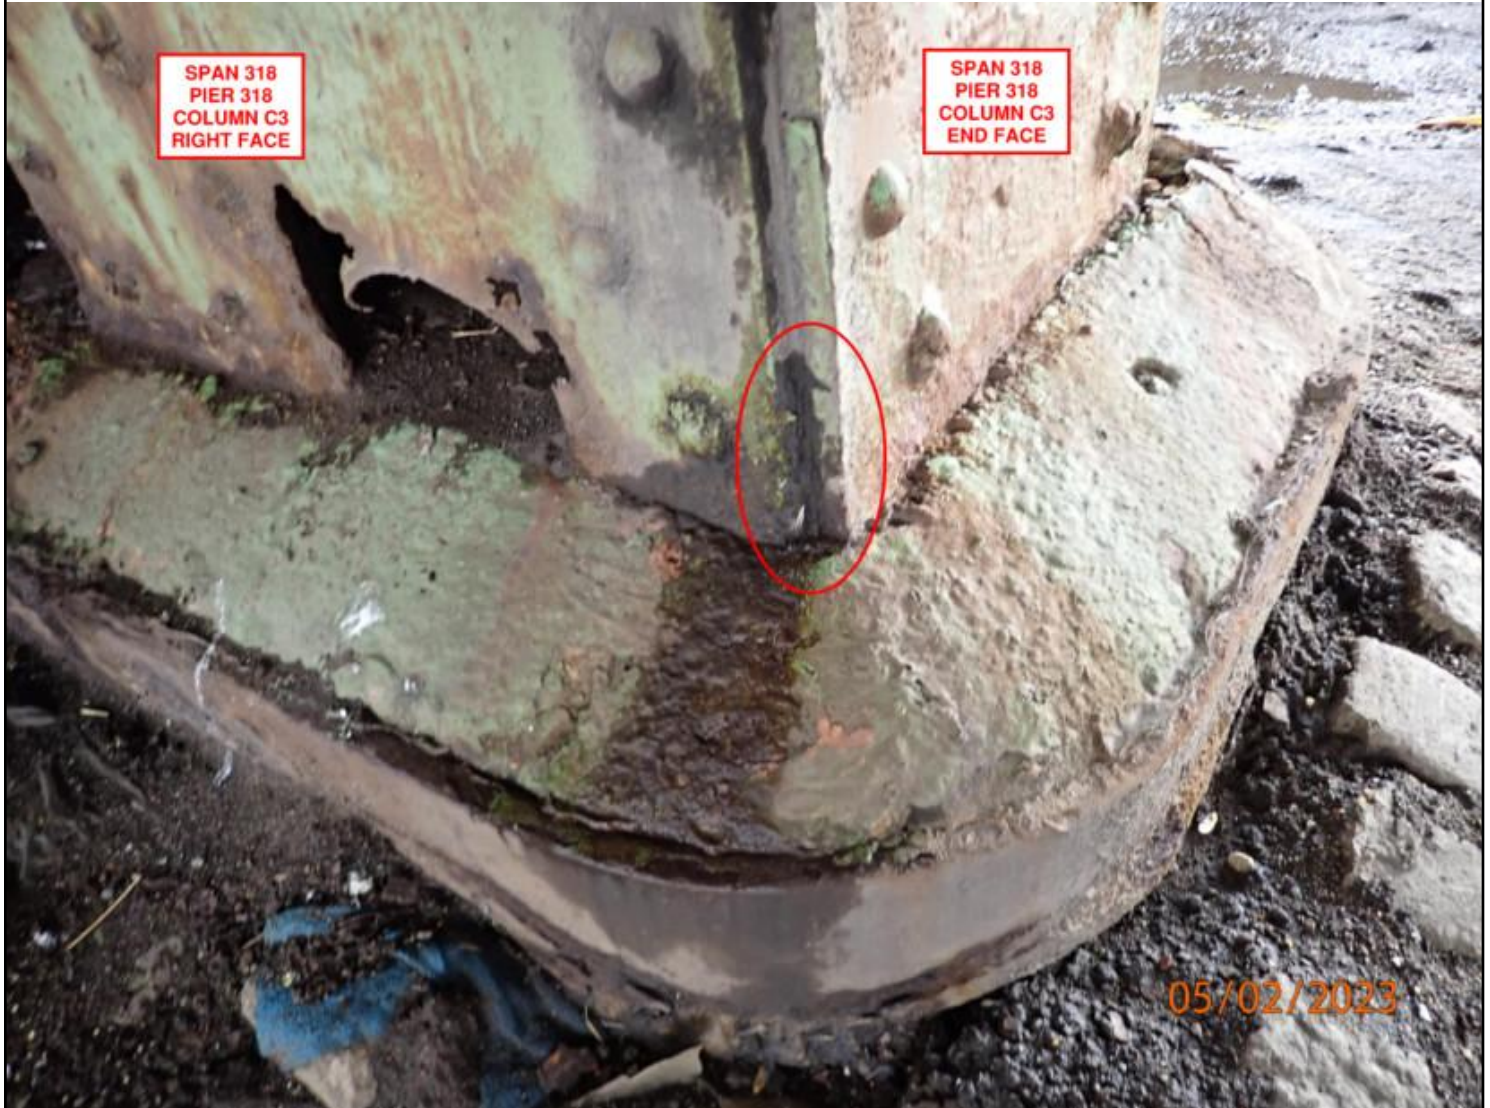
Photo Number: 5

1. Active joint leakage was noted directly above Column C3 with water seeping inside the column.
2. At the right face of the Column C3 there is a perforated steel plate with two small openings with very sharp edges, making access to the inside of the column difficult.
3. Column C3 is located on the wide raised median of Hamilton Avenue and the base was accessed by walking.
4. The broken concrete encasement at the base of Column C3 is issued a NSCO under separate cover.
5. The 2" diameter hole was not included in calculations since it is 3" above encasement.

Attachment Description: Span 318, Pier 318 Column C3 End and Right Faces. Heavy pitting at the base of the column and signs of active leakage (circled). Looking Begin Left.

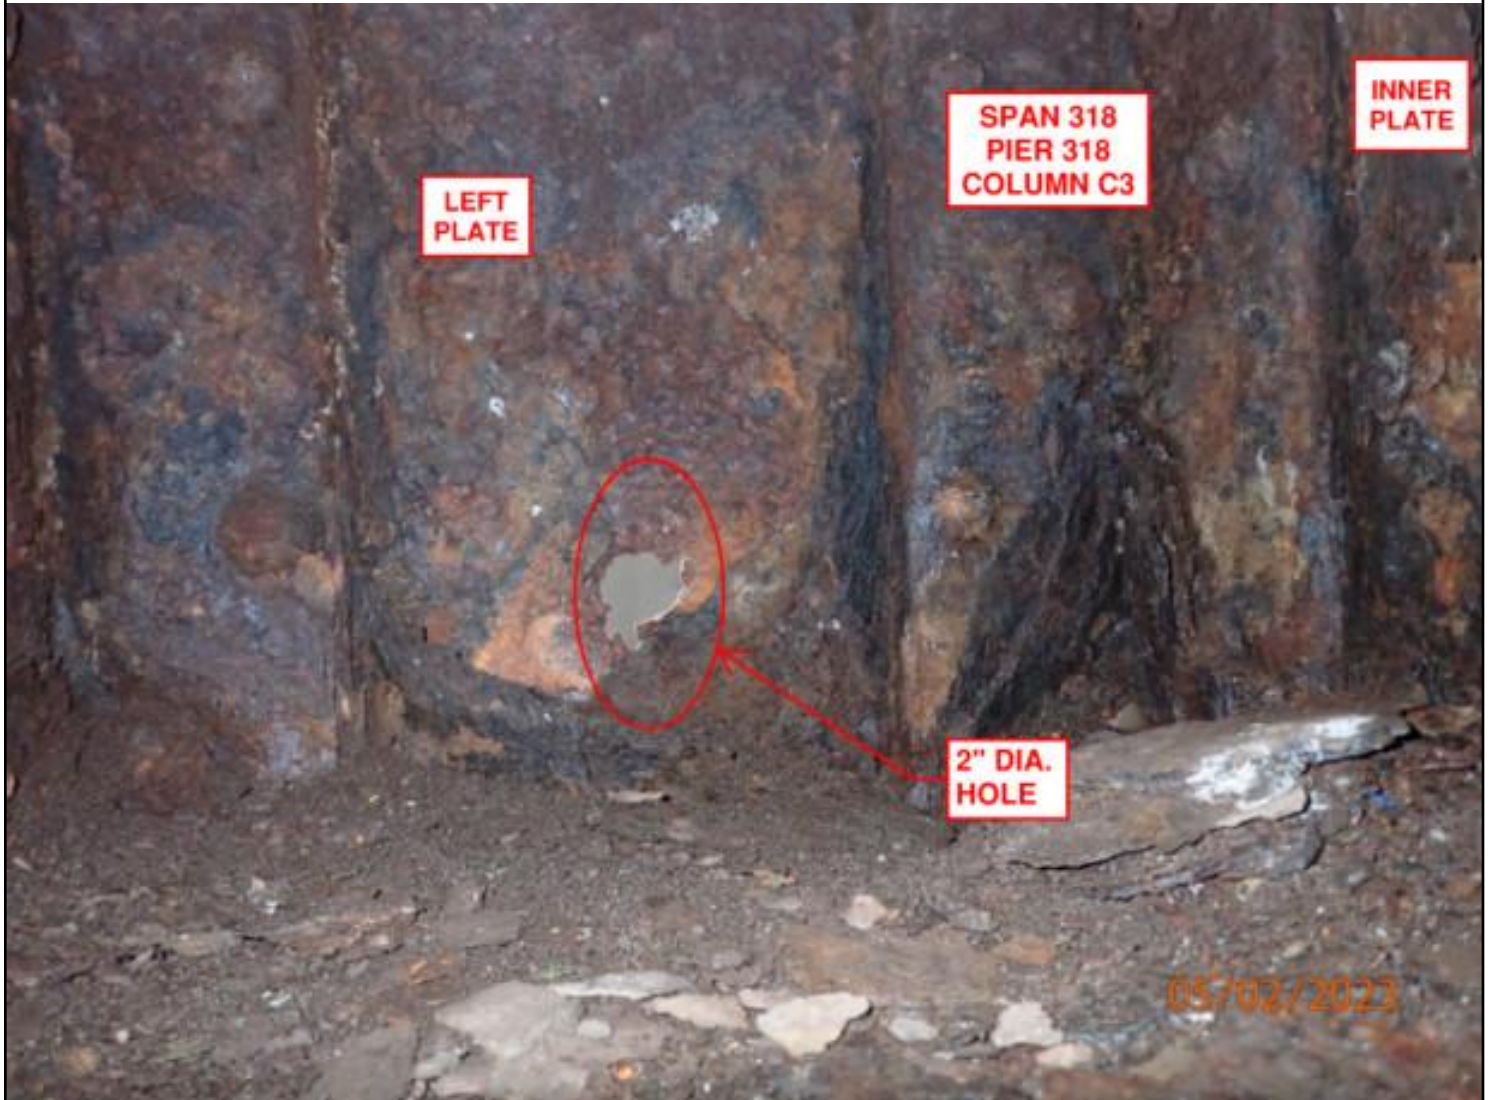
Photo Number: 6

Attachment Description: Span 318, Pier 318 Column C3. Close-up view inside the begin portion of Column C3. Heavy pitting and 2" diameter hole. Looking Left.
